Corrosion damage at the base of the building before the 2018 restoration, Pavillon Le Corbusier

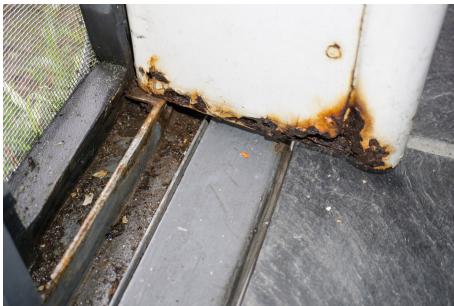
- 1 Stahlskelett mit Rostunterwanderungen und spröden Gummidichtungen der Fenster vor der Restaurierung 2018, Pavillon Le Corbusier. Abbildung: Silvio Schmed und Arthur Rüegg.
- 2 Lüftungsflügel mit Rostfrass vor der Restaurierung 2018, Pavillon Le Corbusier. Abbildung: Silvio Schmed und Arthur Rüegg.

After the expiry of the building rights agreement, the pavilion reverted to the City of Zurich in 2014. A feasibility study conducted by Silvio Schmed and Arthur Rüegg in 2015 identified three major problem areas. First, the building envelope was no longer leakproof, affecting both the concrete of the basement and the ramp, as well as the neoprene seals in the glass façade. Rust was eating holes in the sheet metal. The paint coatings of the steel umbrellas contained toxins 250 times higher than the permitted level. Second, the infrastructure was defective. As a result of corrosion, the underfloor heating had not functioned since 1982, and the climate in the basement ruled out exhibiting
